**Operation and Maintenance Report
January 2016 to December 2016**

McCormick and Baxter Superfund Site

Portland, Oregon

March 23, 2017

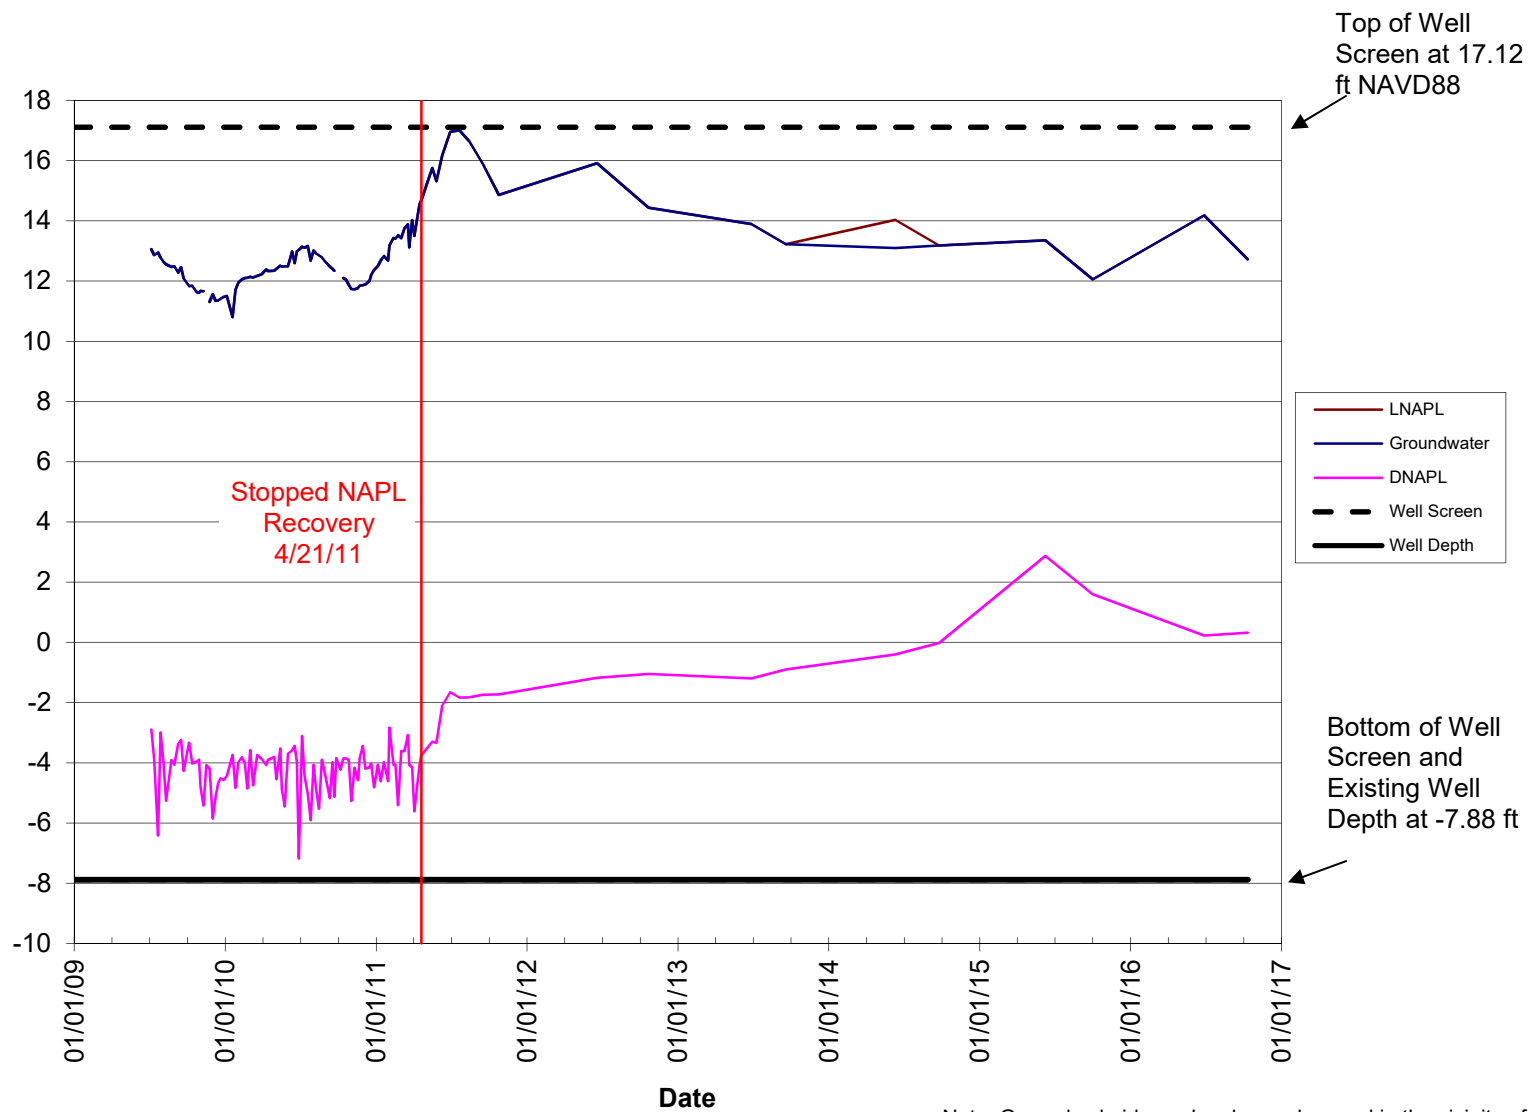
McCormick and Baxter Superfund Site
Portland, Oregon
**2009 to 2016 NAPL Thickness Plot
for Well EW-1s**

Note: Ground subsidence has been observed in the vicinity of EW-1s and the well casing has sunk over time. The screened interval and total well depth have been referenced to the most recent ground survey from September 2009. Given that the elevations are changing with time, the elevations shown are approximate.

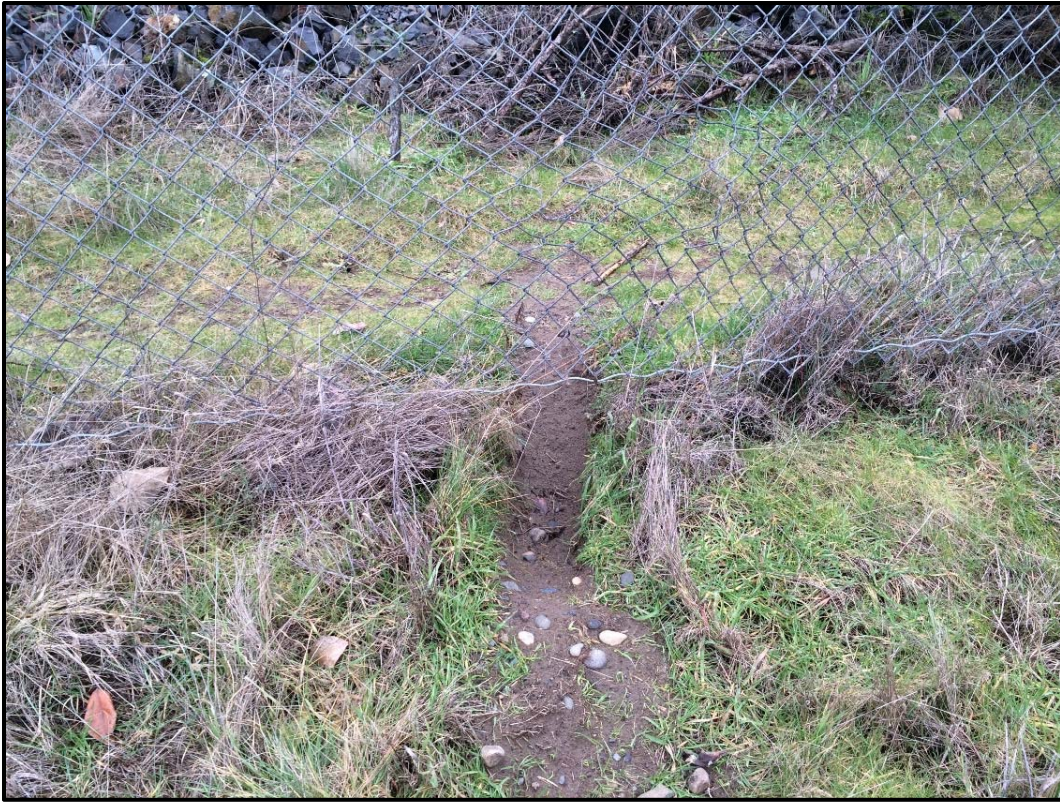
Photograph 1 – Animal burrow located along north fence.

On January 20, 2016, burrows were filled around the perimeter fence and locks were replaced on the two gates leading to the trailer area. Nesting birds created holes in the job trailer in 2015 and the trailer was tarped in early February 2016. The tarp later blew off following a winter storm and on February 19, 2016, the holes were filled with foam and covered with plywood (Photographs 5 and 6; Appendix A). The pump that drains the stormwater collection sump in the drum storage area was replaced on March 2, 2016. Repairs to the east fence were made on July 21, 2016. The backflow preventer on the waterline was tested on September 16, 2016.

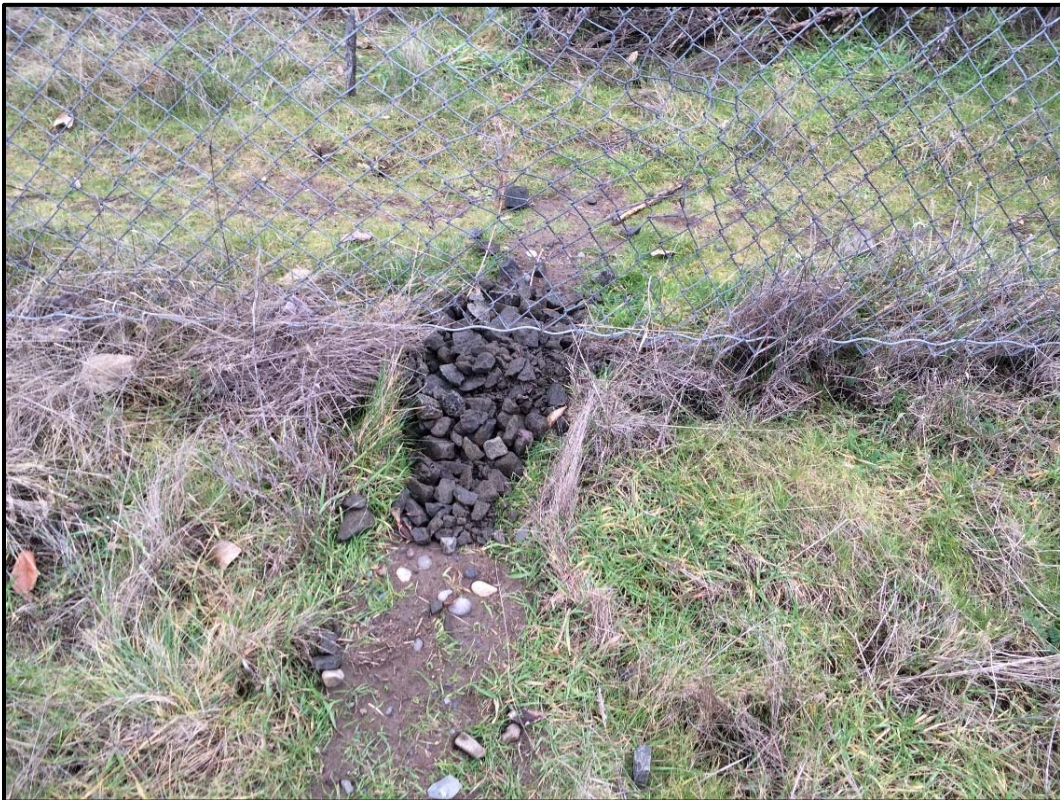
Photograph 2 – Filled in animal burrow located along north fence.

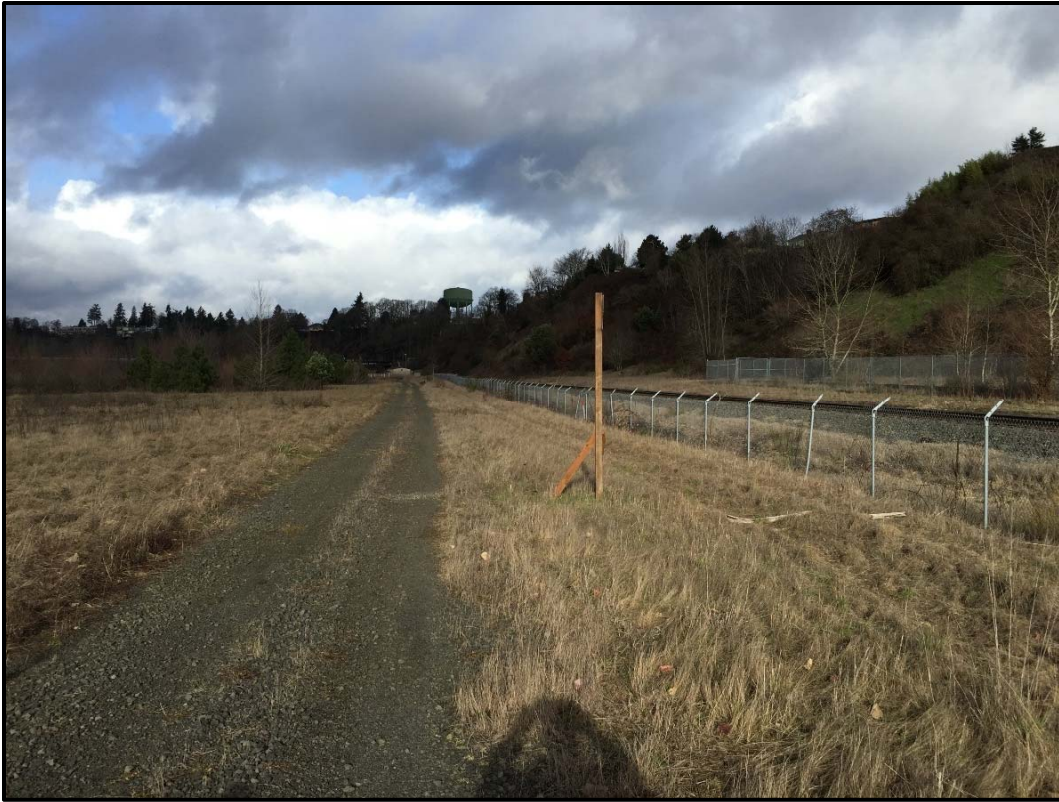
warning sign were found damaged during the January 2016 site visit, and subsequently repaired (Photographs 3 and 4; Appendix A).

Photograph 3 – Repaired sign at southeast corner of site, looking north.

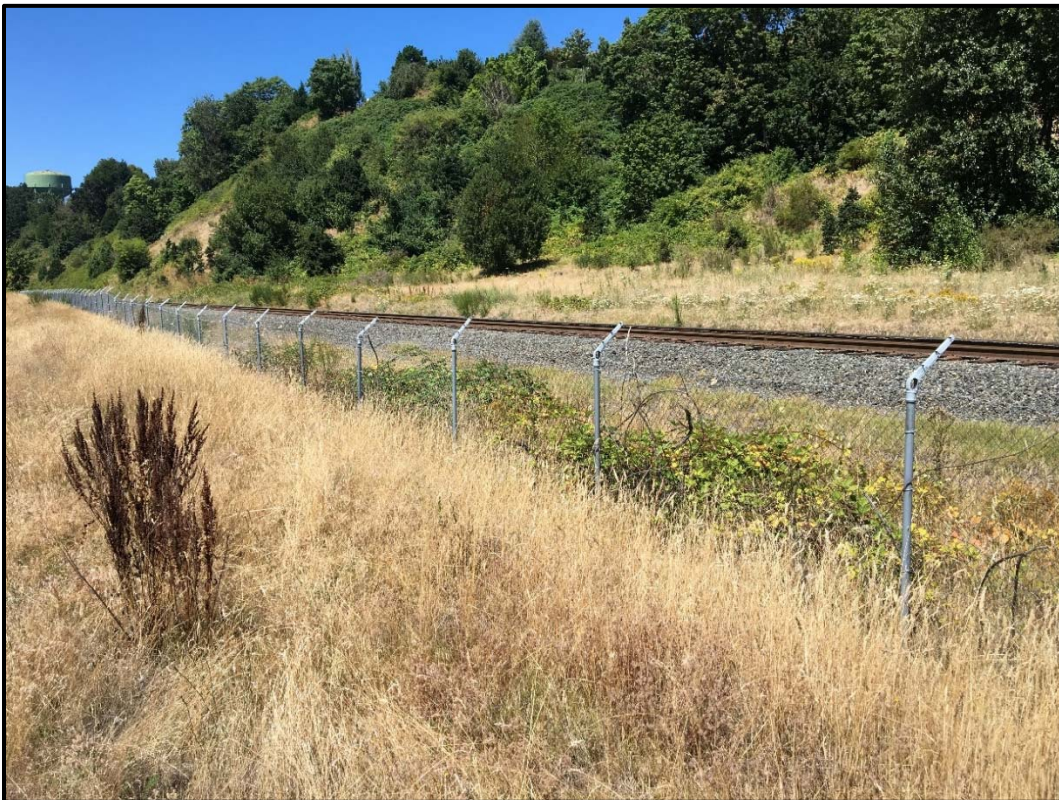
Photograph 4 – Repaired fence – July 2016.

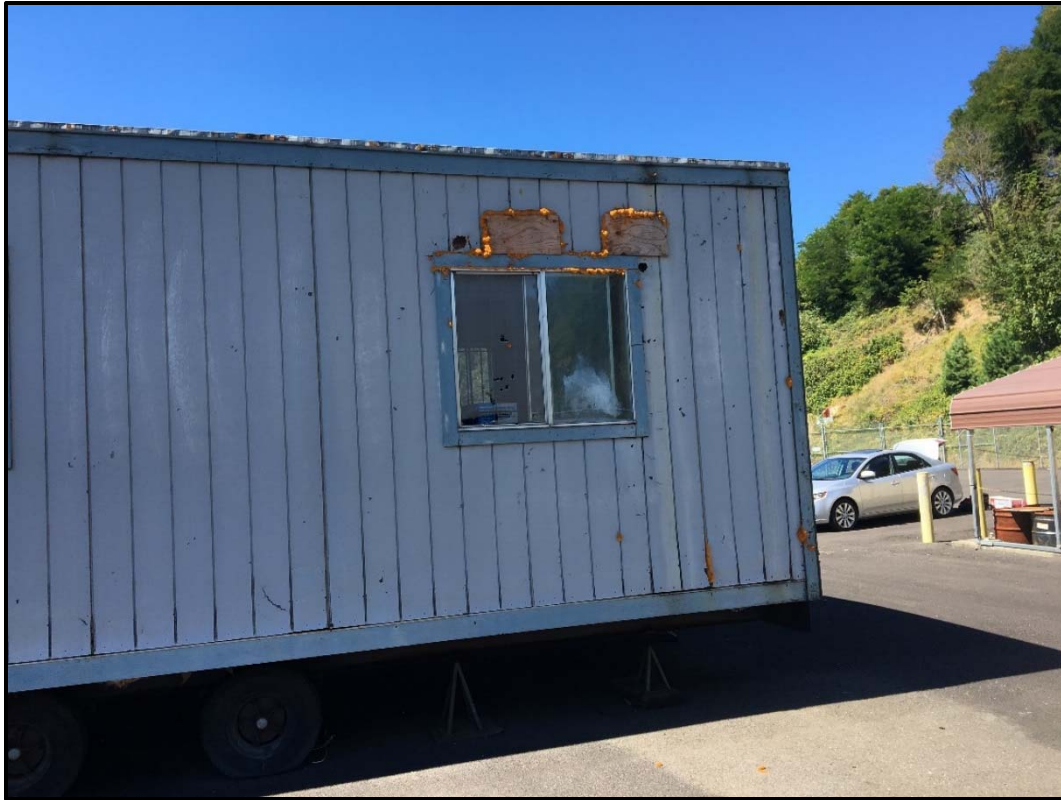
Photograph 5 –Repairs to trailer siding caused by birds.

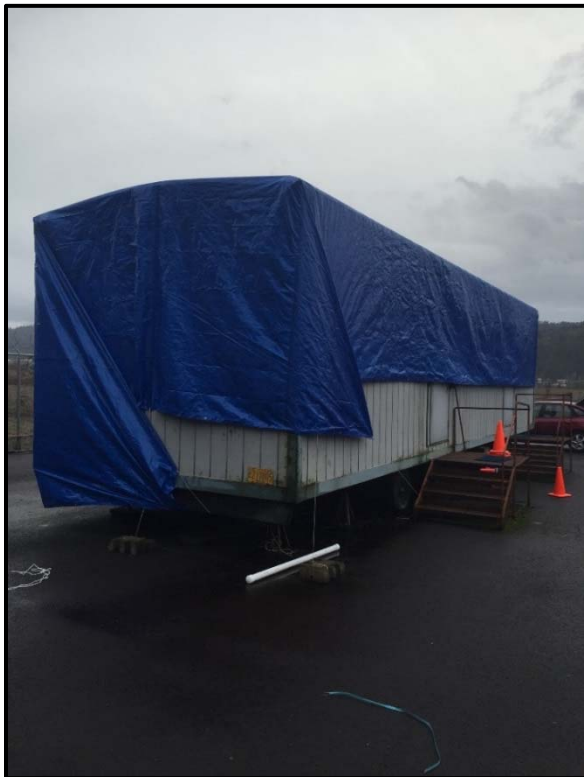
Photograph 6 –Trailer tarped to prevent further leaks from holes in siding.

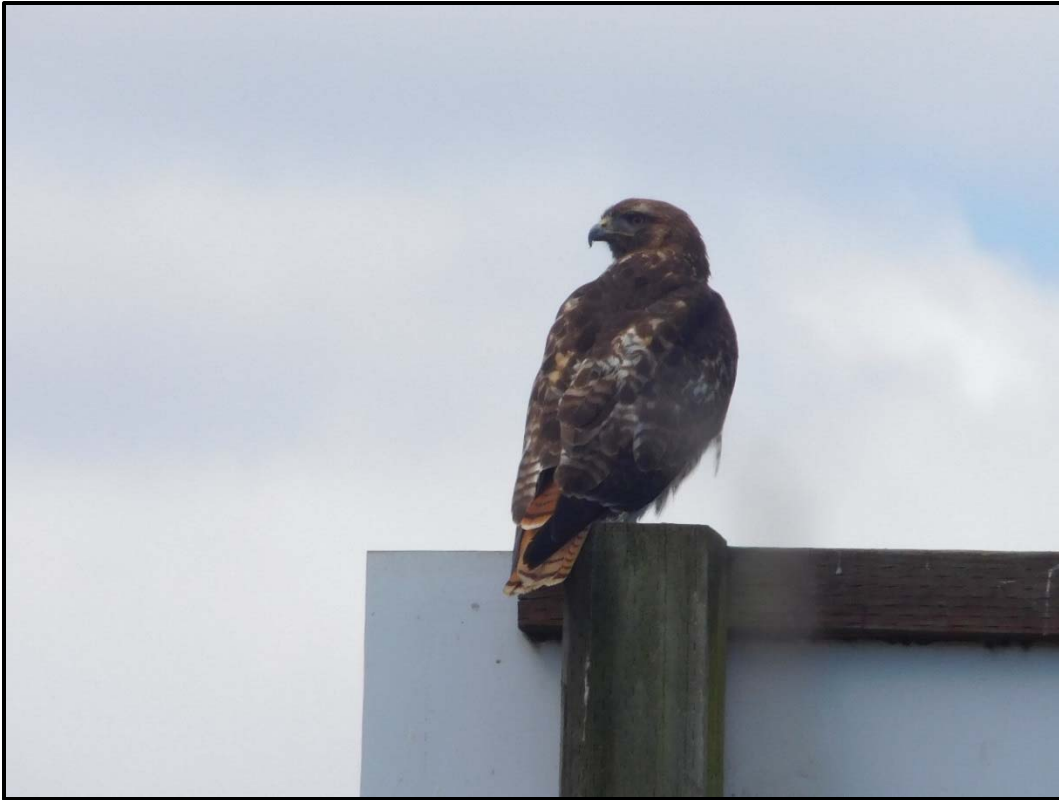
Numerous wildlife species continue to be observed site-wide; various birds seen most frequently include Canada geese, gulls, cormorants, pigeons, blue herons, ospreys, hawks (Photograph 7; Appendix A), and flickers.

Photograph 7 – Red tail hawk observed during June 2016 vegetation inspection.

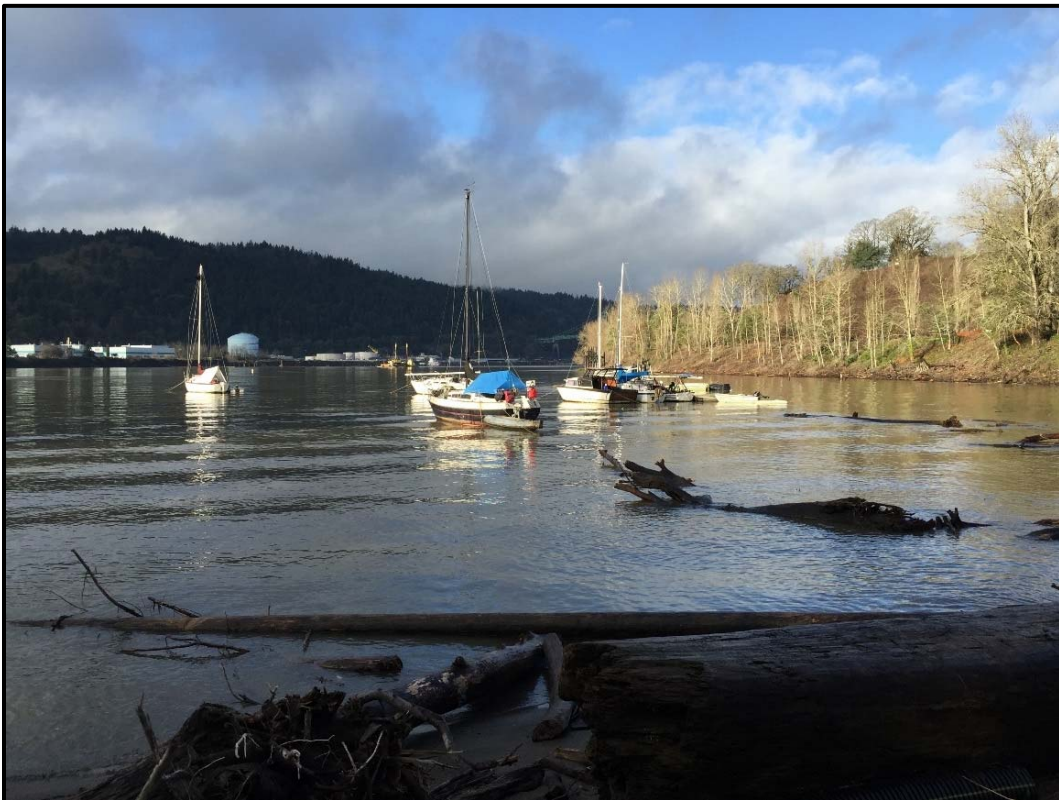
Numerous dilapidated boats (used as dwellings) were seen anchored in the Willamette Cove during every site visit (Photograph 8, Appendix A). Boats were not observed to be anchored on the sediment cap during site inspections. No effects to the sediment cap were observed from mooring or from physical contact with these boats on the sediment cap. The US Coast Guard and Oregon State Marine Board rules prohibit anchoring on the sediment cap.

Photograph 8 – Vessels moored in Willamette Cove – November 2016.

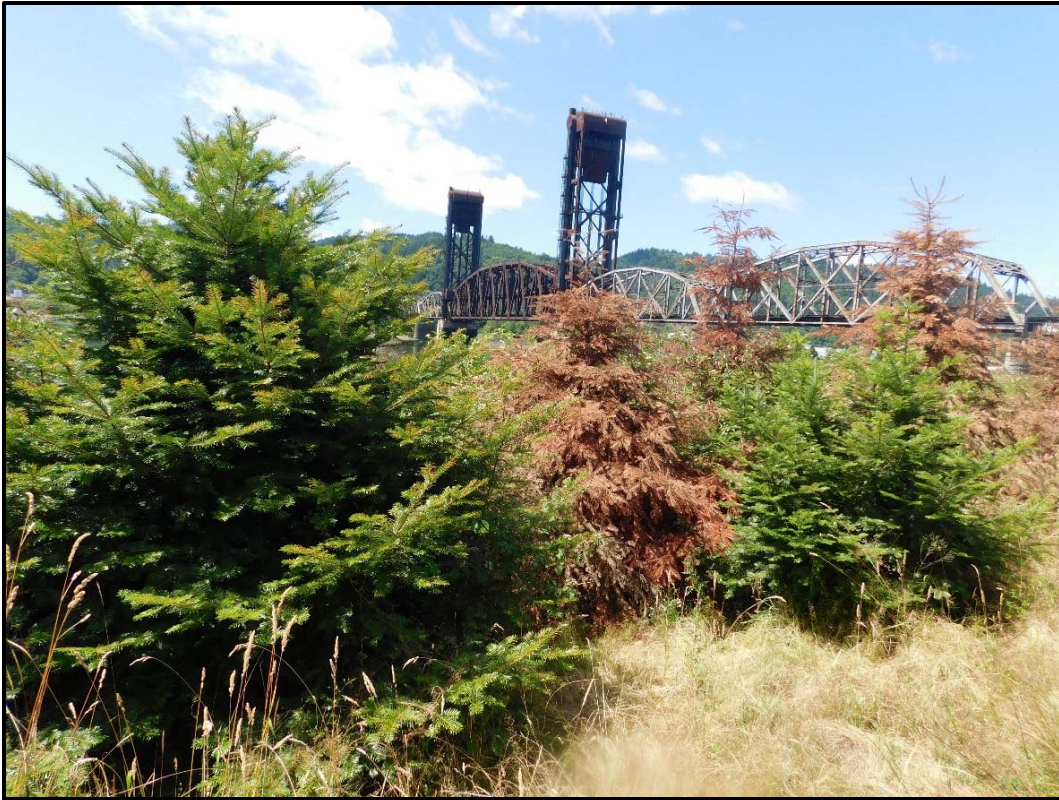
Photograph 9 – Healthy trees adjacent to trees that perished during the 2016 summer drought – June 2016.

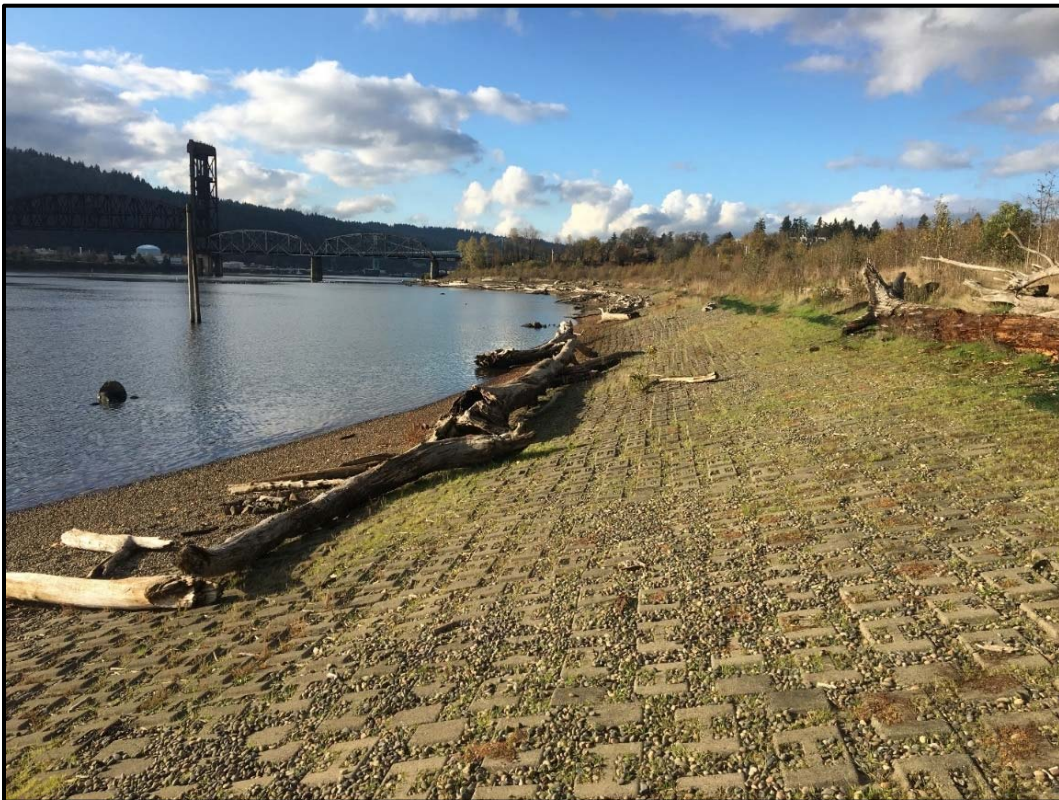
placed within the ACB voids along a large portion of the shoreline and Willamette Cove in October 2012. The gravel has largely remained in place through 2016; however, some has washed down steeper shorelines and has settled onto lower ACB surfaces. Shoreline conditions and the distribution of the ACB gravel are shown in the Photograph Log (Appendix A).

Photograph 10 – Typical habitat gravel within ACB armoring along the Willamette River – November 2016.

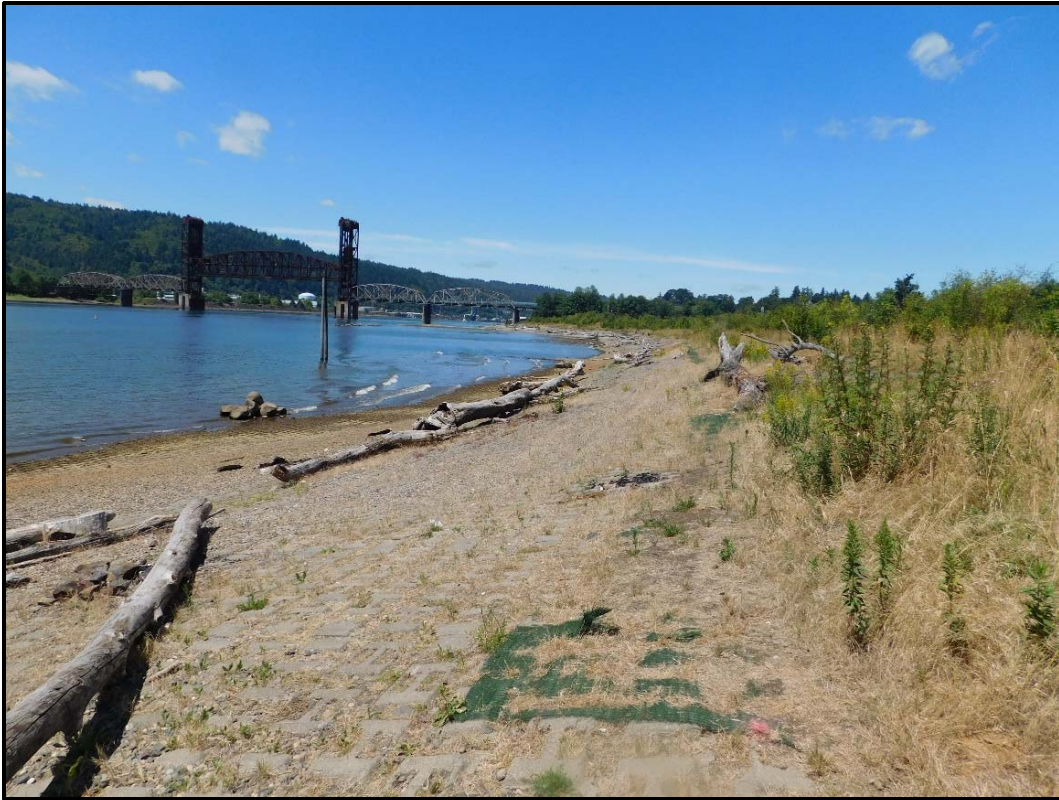
Photograph 11 – Looking north at TRM repairs during June 2016 vegetation inspection.

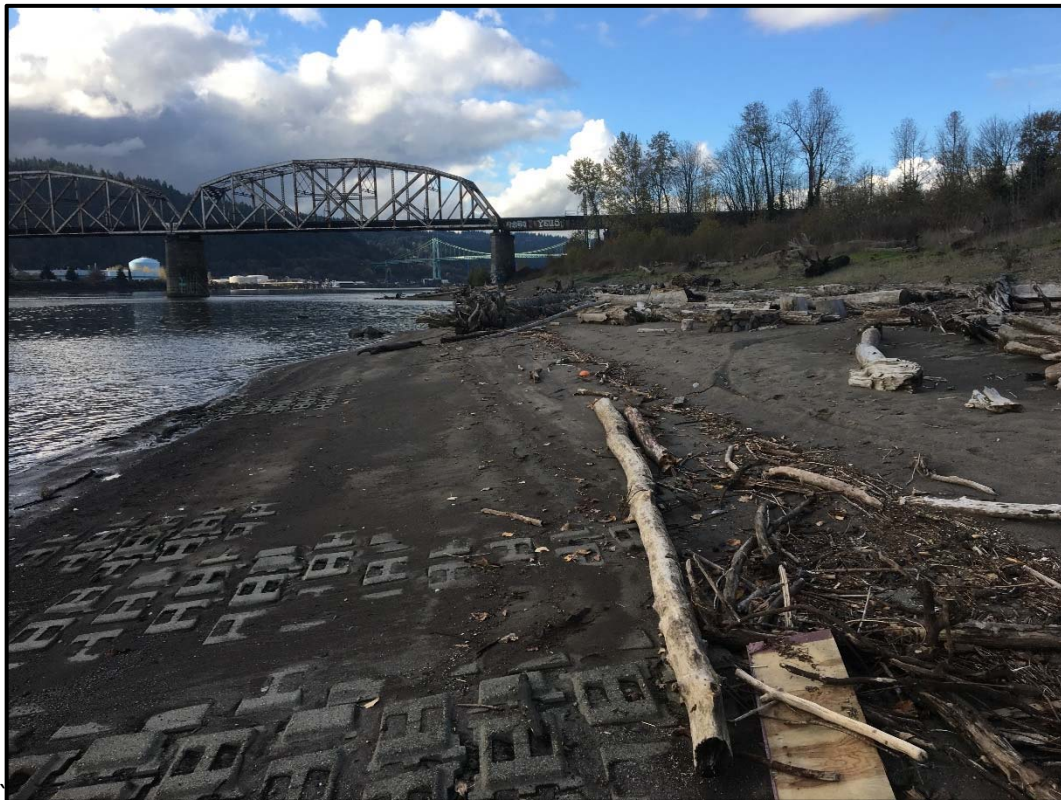
Photograph 12 – Lower portion of the ACB armoring in November 2016.

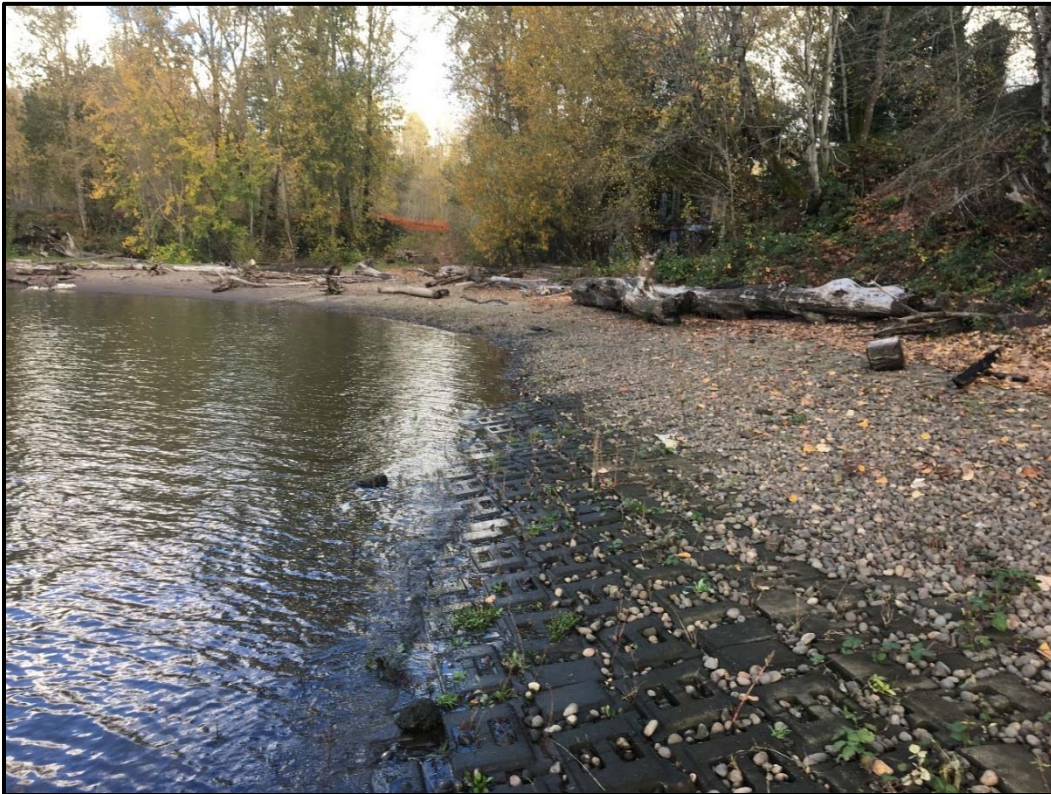
Photograph 16 – Typical habitat gravel within ACB armoring in Willamette Cove – November 2016.

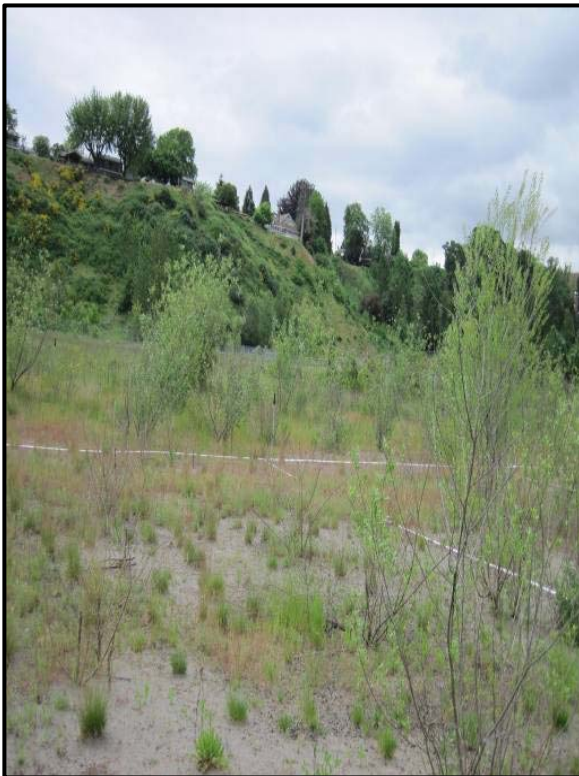
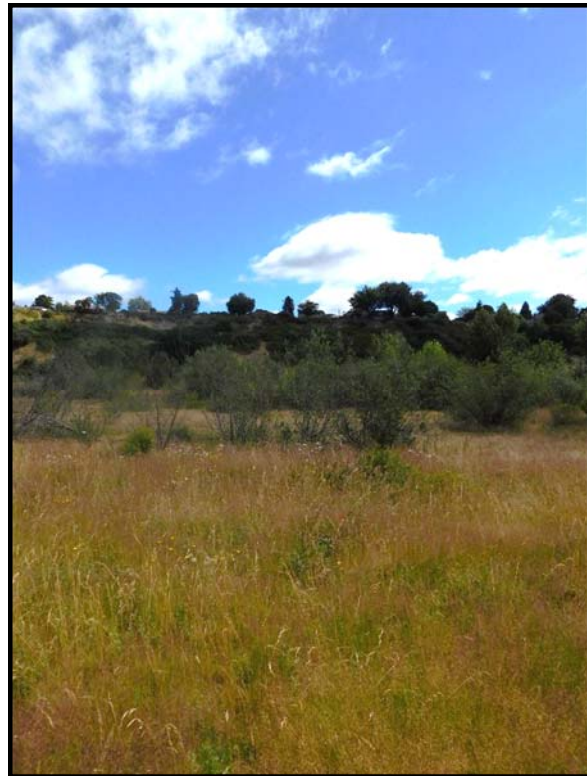
Photograph 4 – View of stormwater pond. Willow and alder have increased in size, although most of the pond remains barren or vegetated with grasses. The irrigation system was removed in 2016. Taken looking northeast from Photograph Location 4 comparing baseline and current conditions. (Left - June 2011, Right - June 2016)

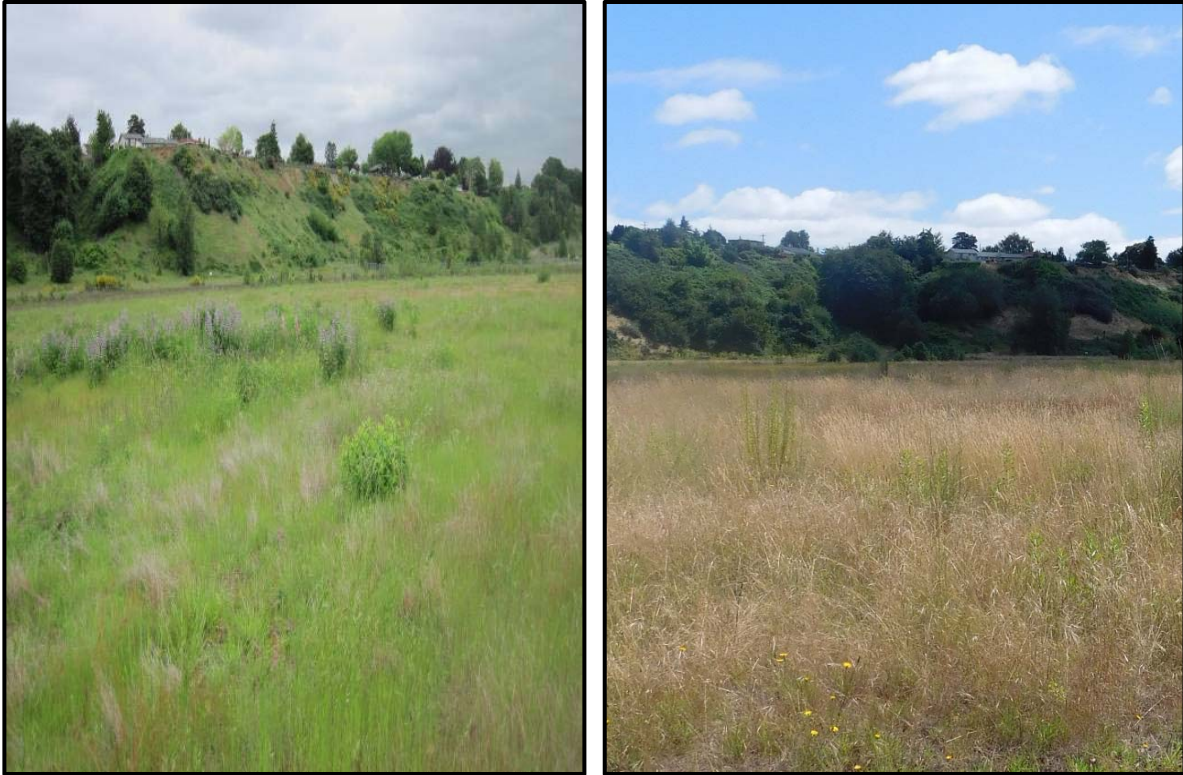
Photograph 6 – Impermeable cap dominated by grasses and herbaceous vegetation. Baseline photograph on the left taken looking east from Photograph Location 6 (June – 2011). Current conditions from June 2016 shown on the right. Cat’s ear visible at bottom of photo on the right.
